Conservation of Built Heritage and Concept of Anastylosis: Problems, Practices and Intended Mitigated Measures in Pakistan

Photographs Showing Before and After Conservation Work at Built Heritage in Pakistan

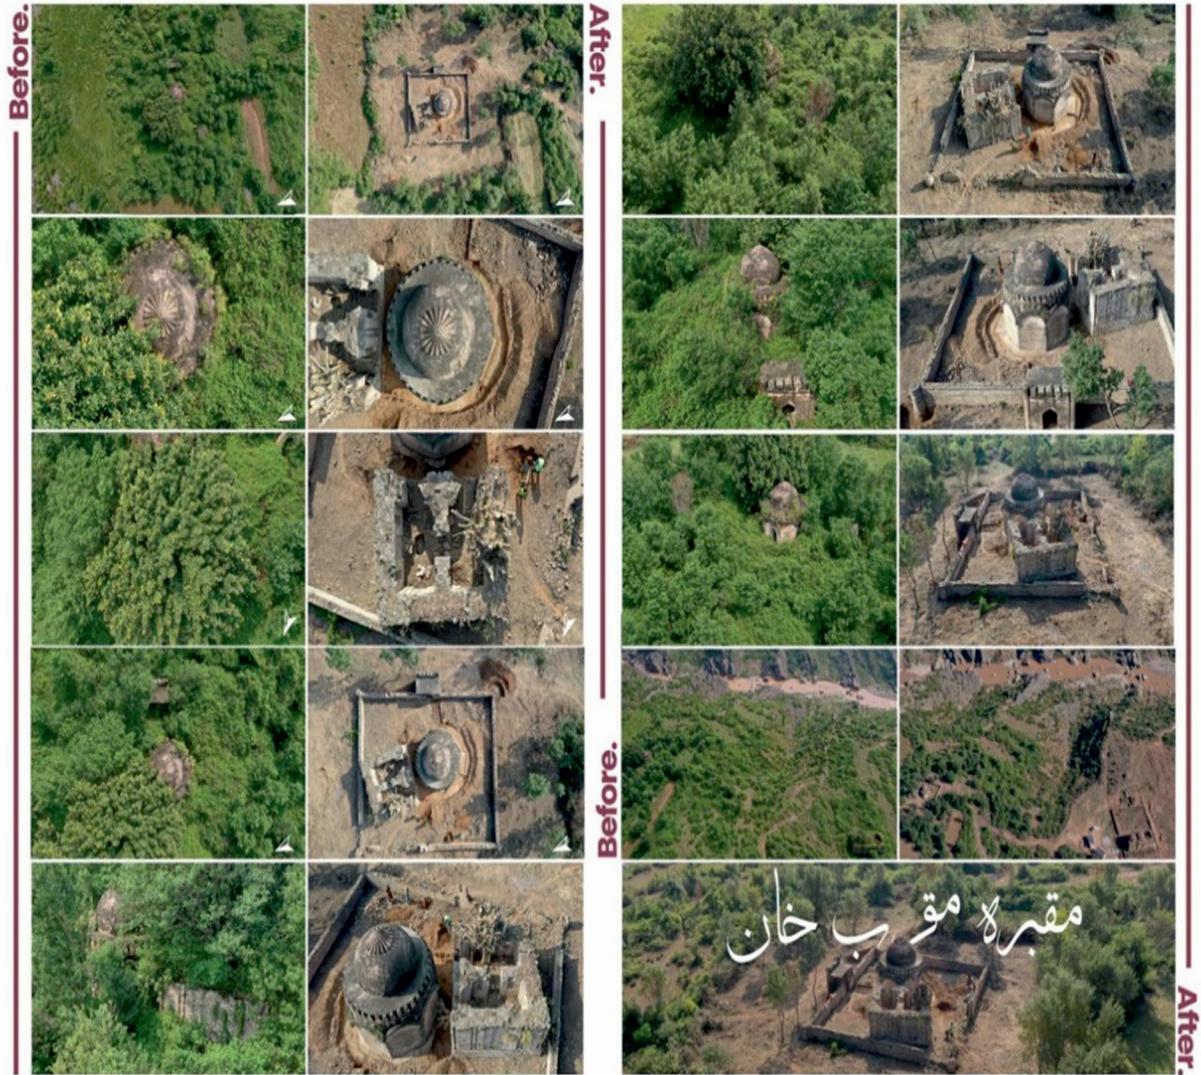
MUQARAB KHAN TOMB

Before_____After

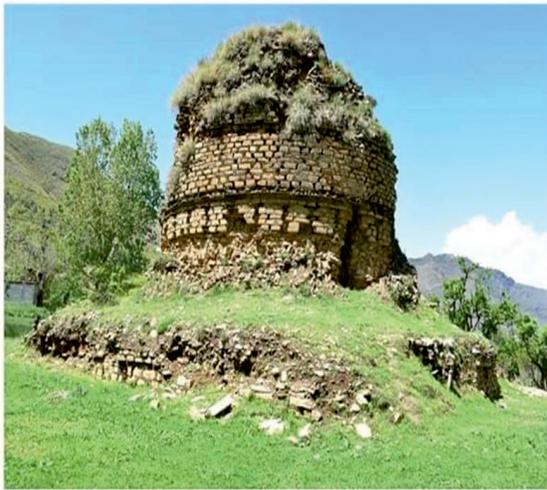
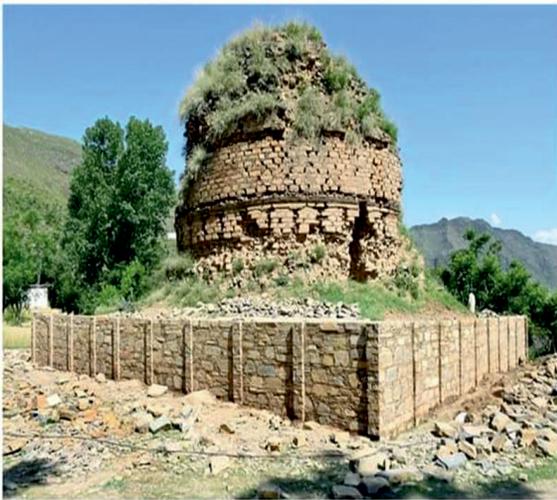
**Conservation / Preservation work of
Shinashah Stupa, Swat.**

Before

After

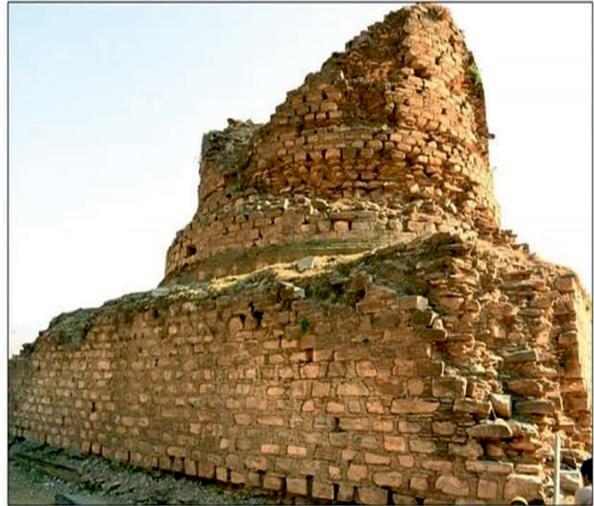
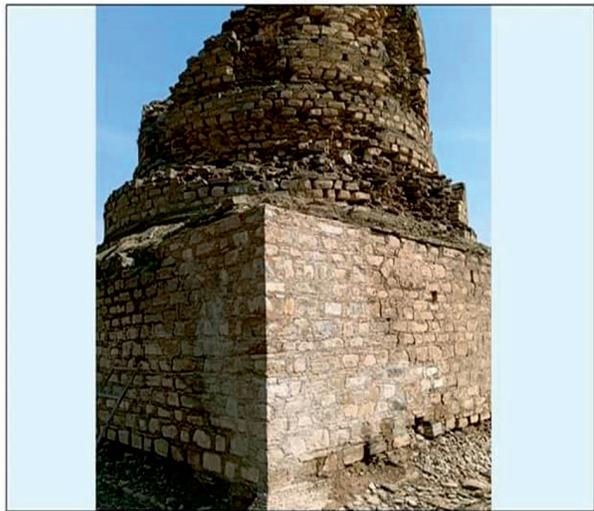
**Conservation / Preservation & Developmental work of
Gumbatona site, Swat.**

Before

After
